THE GREAT ALASKA EARTHQUAKE

Volume II

Illustrations and Maps

TECHNICAL REPORT NO. AFWL-TR-65-92, Vol II

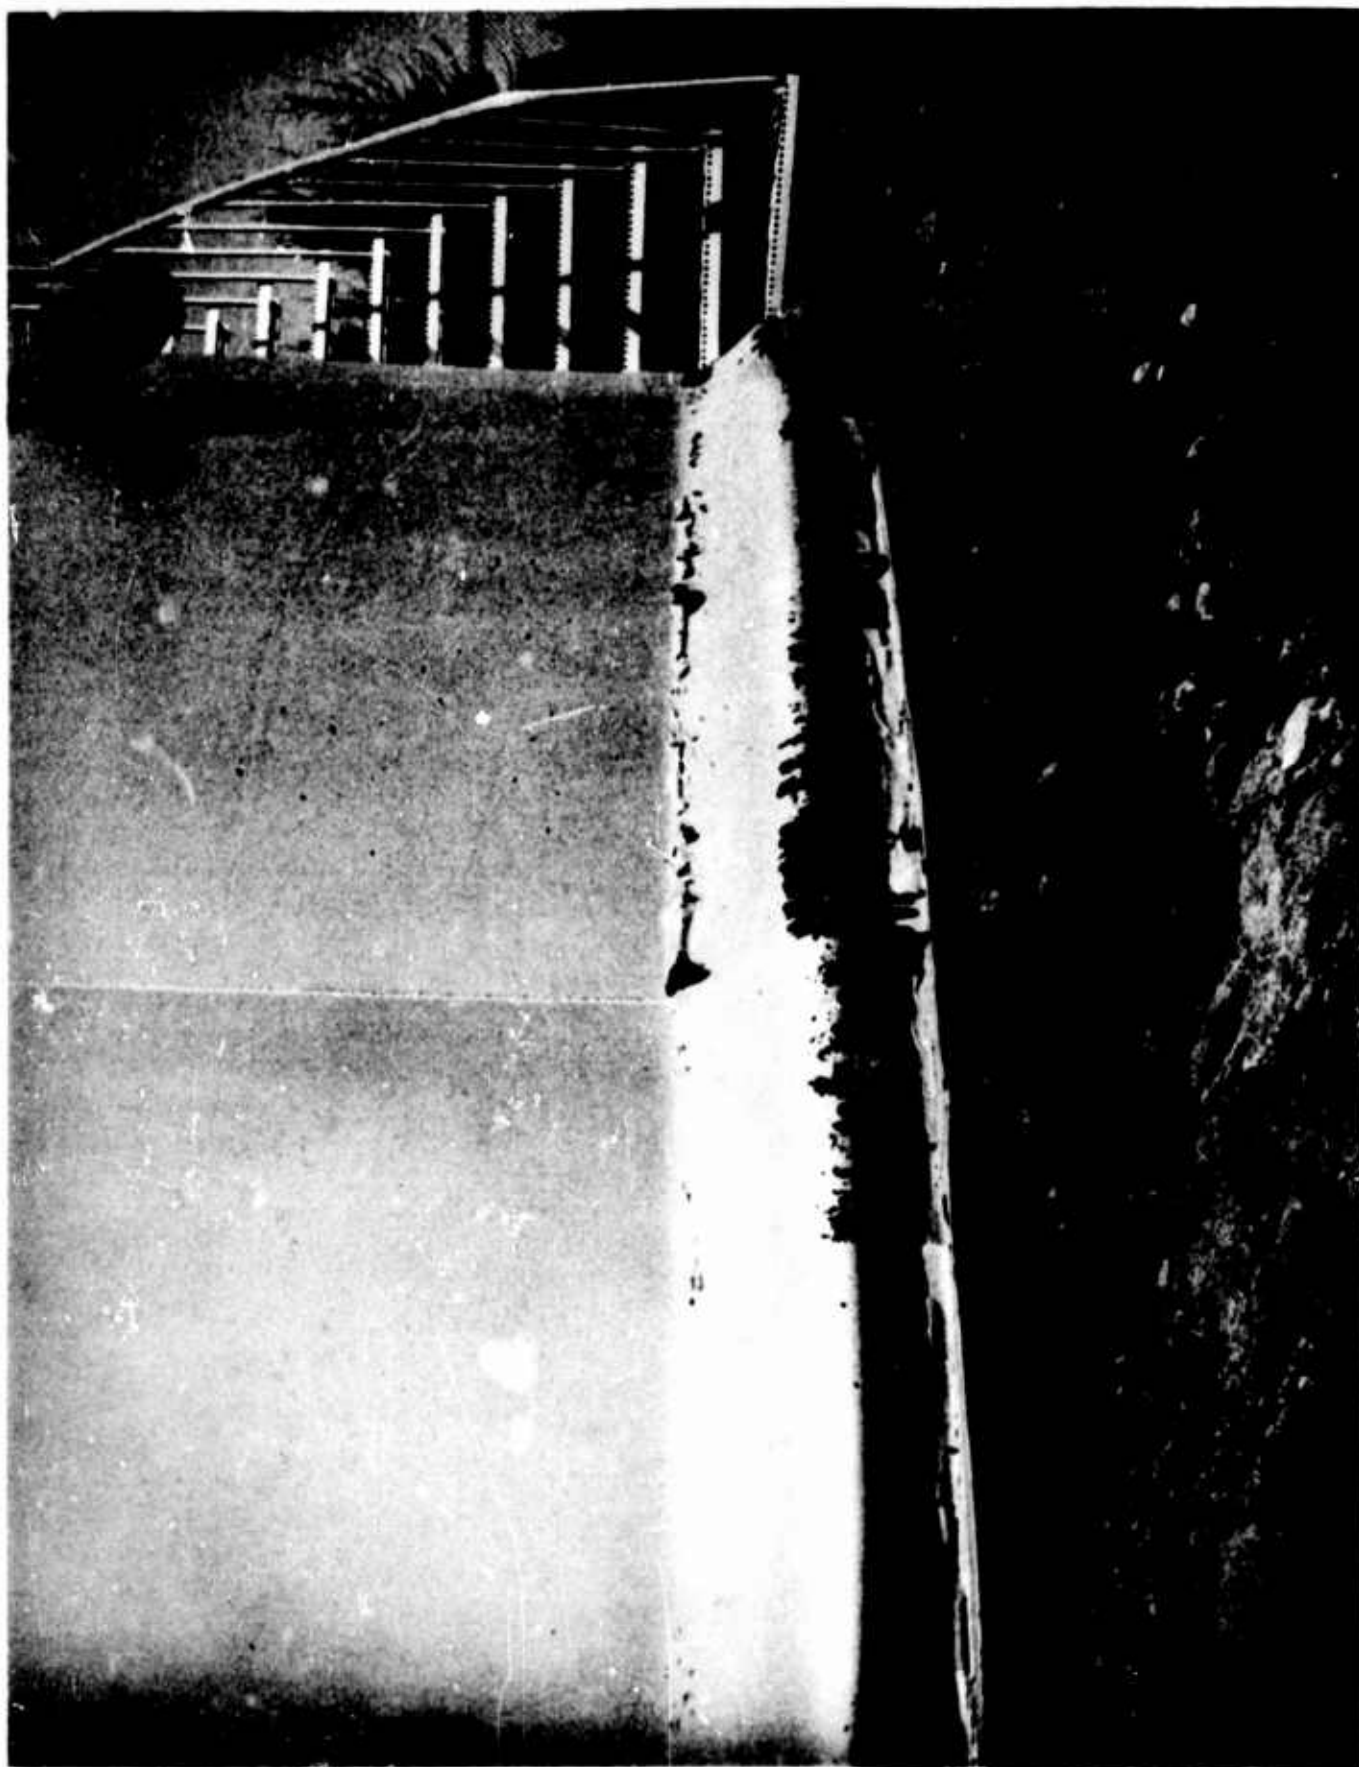
Figure 242. Shell Oil Company International Airport Storage Tank (Closeup of buckle at base of tank)

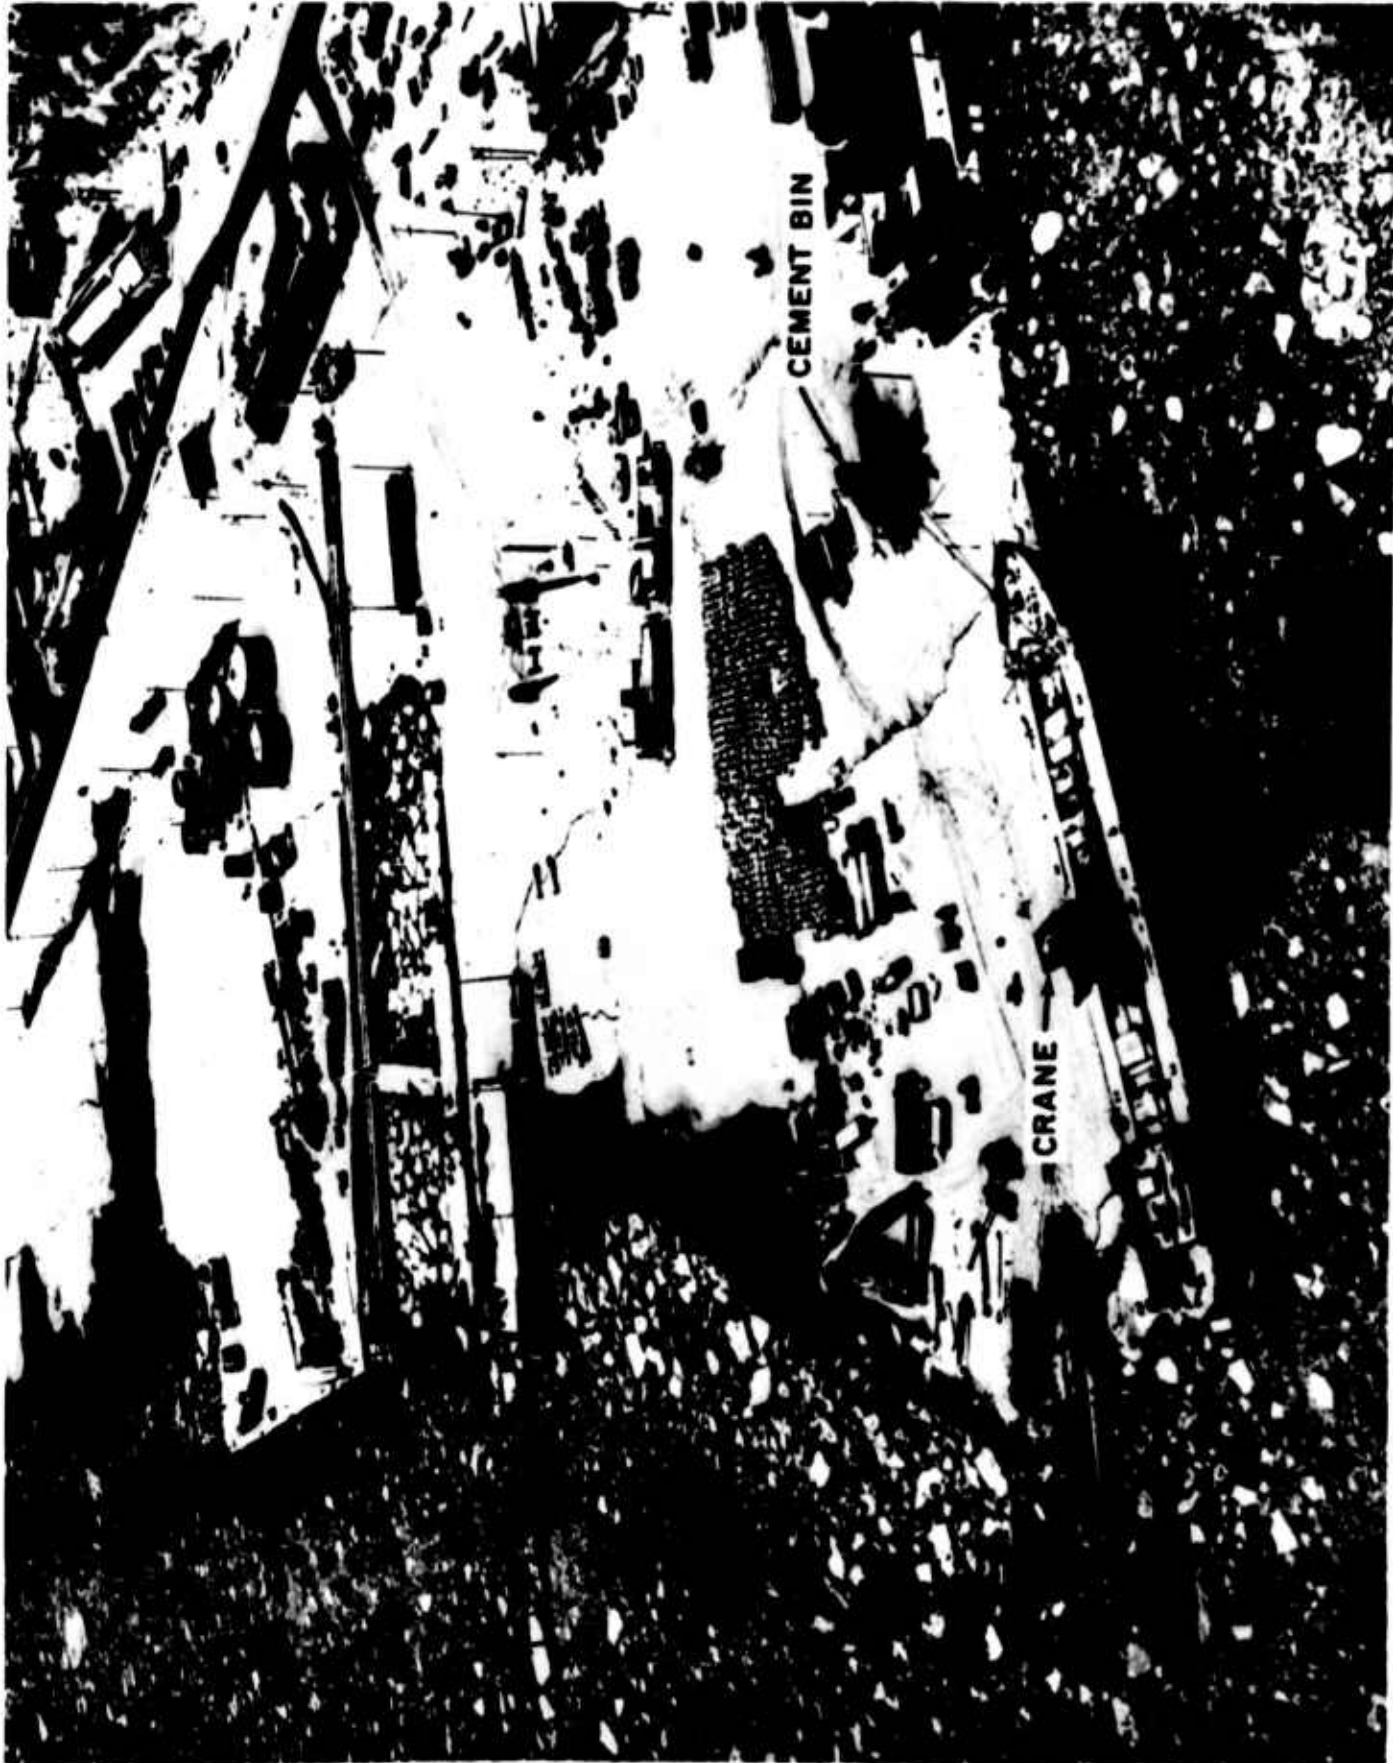
Figure 243. Alaska Aggregate Corporation Dock (Aerial view showing fallen crane and cement bin)

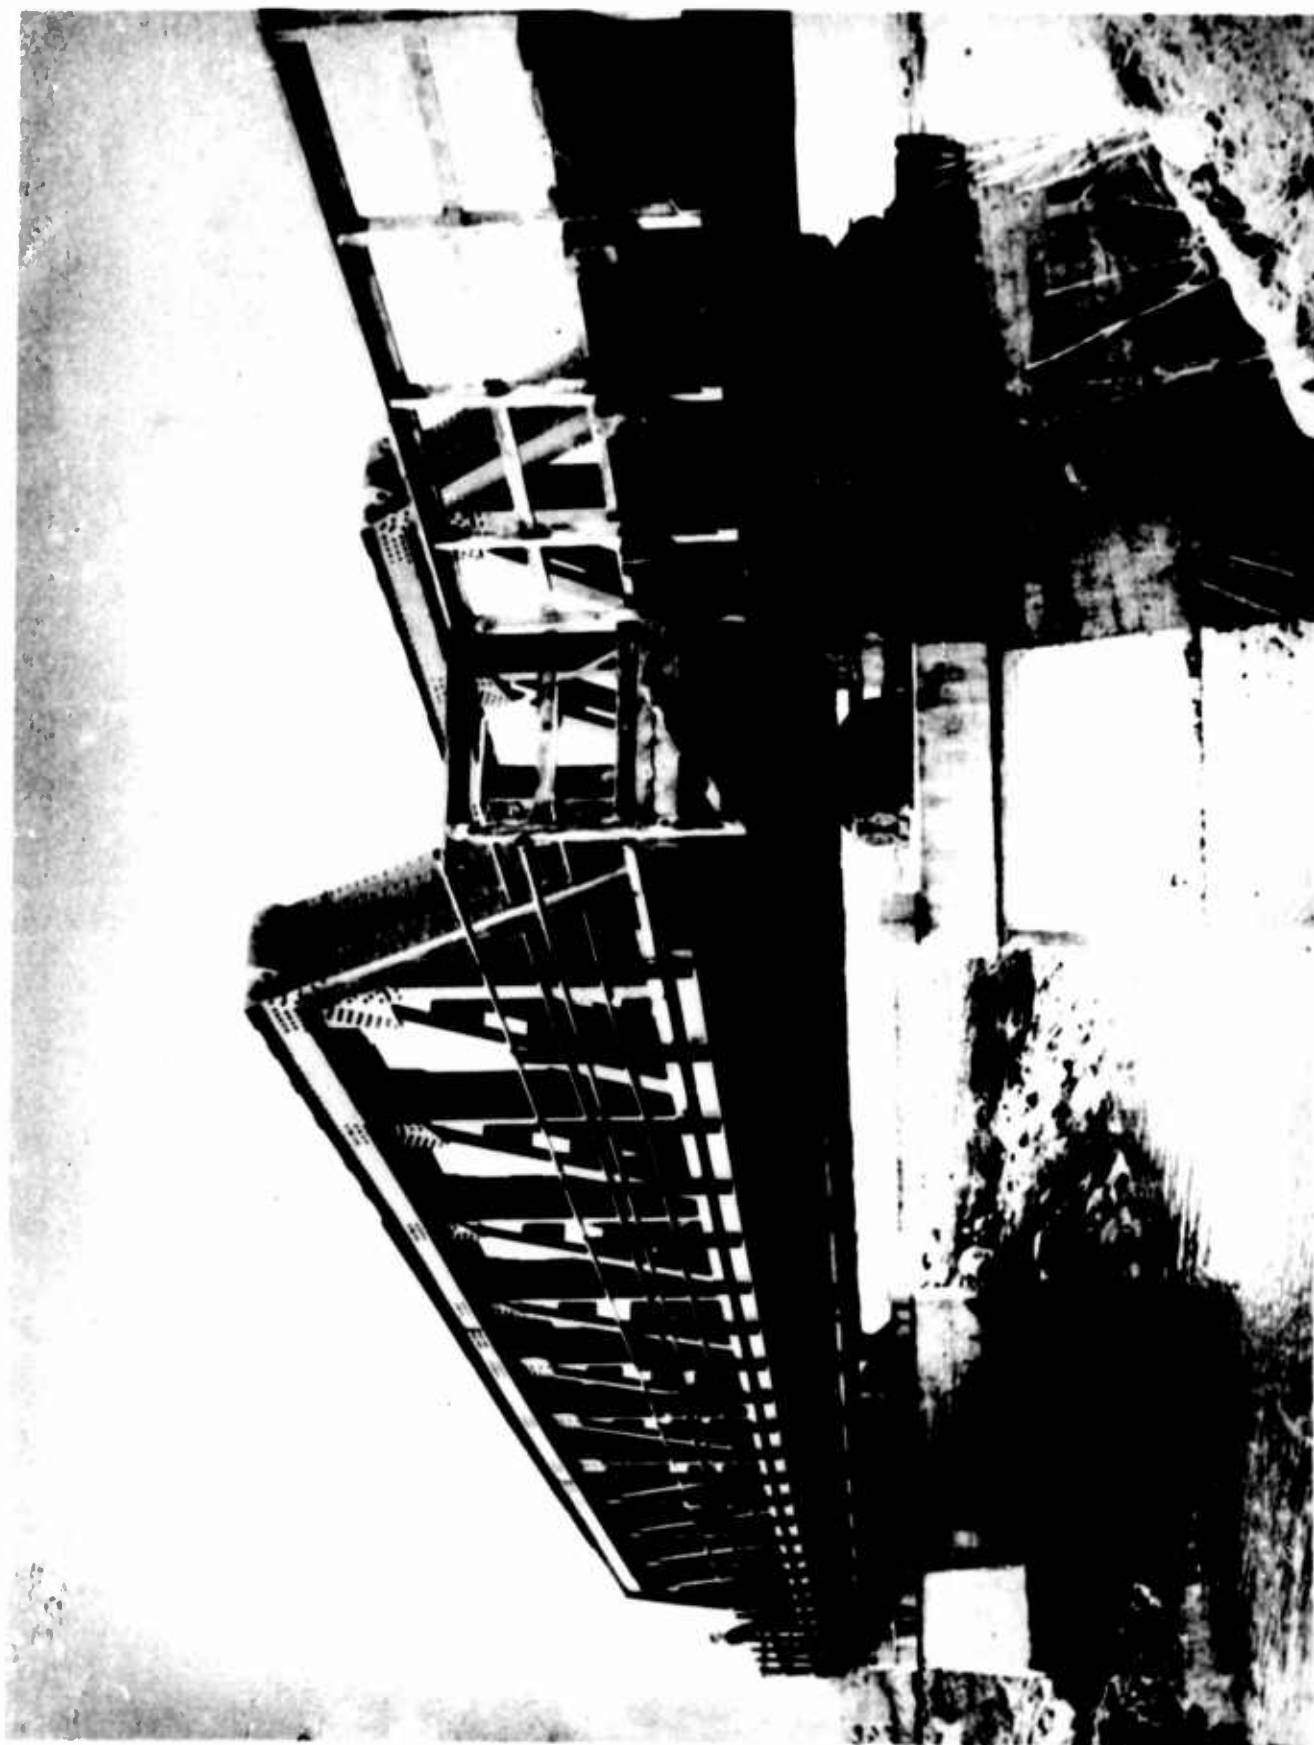
Figure 245. Alaska Railroad Ship Creek Inlet Bridge
(Neither the bridge nor any of the abutments suffered noticeable earthquake damage)

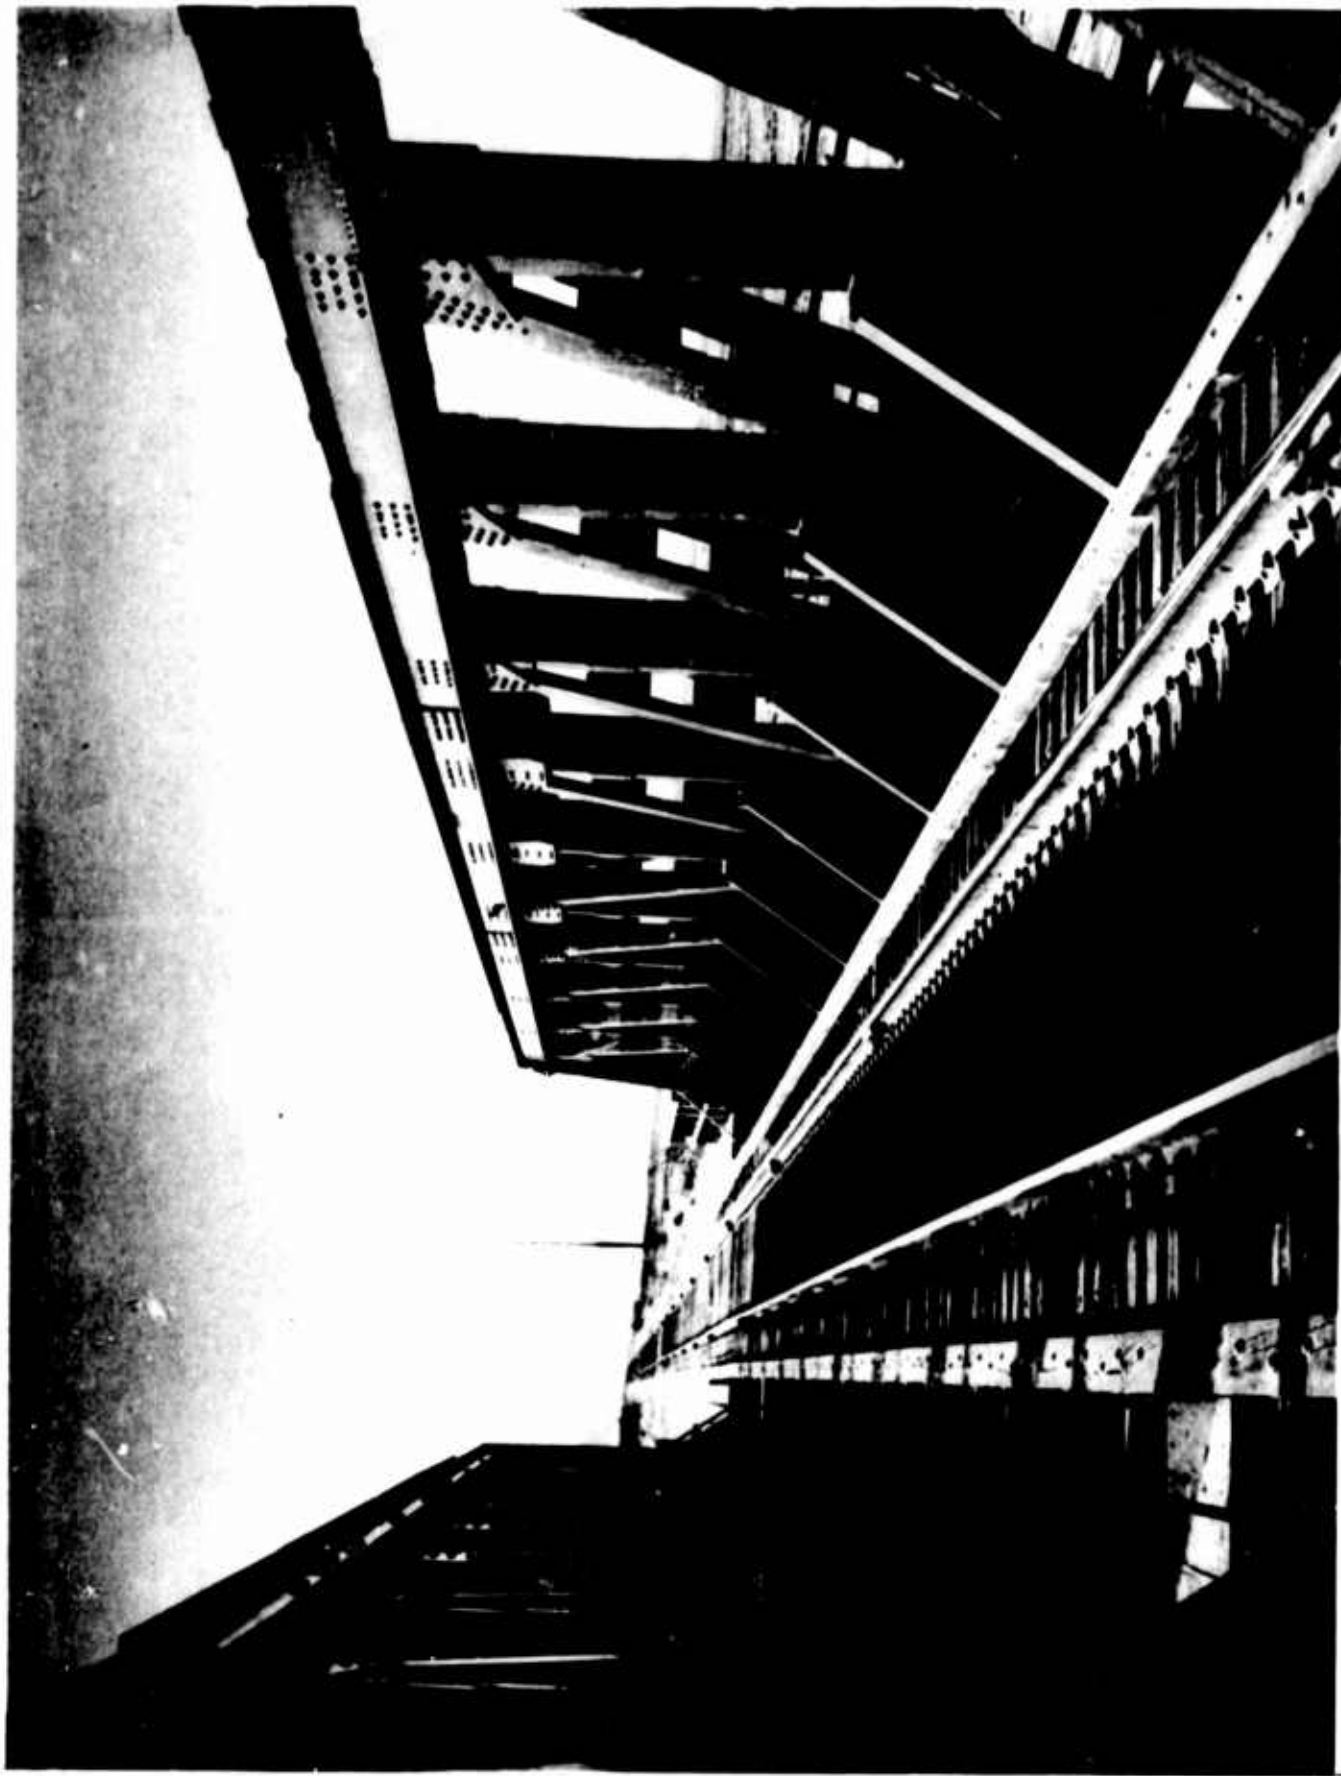
Figure 246. Alaska Railroad Ship Creek Inlet Bridge
(Tracks appear to be in good condition after the earthquake)

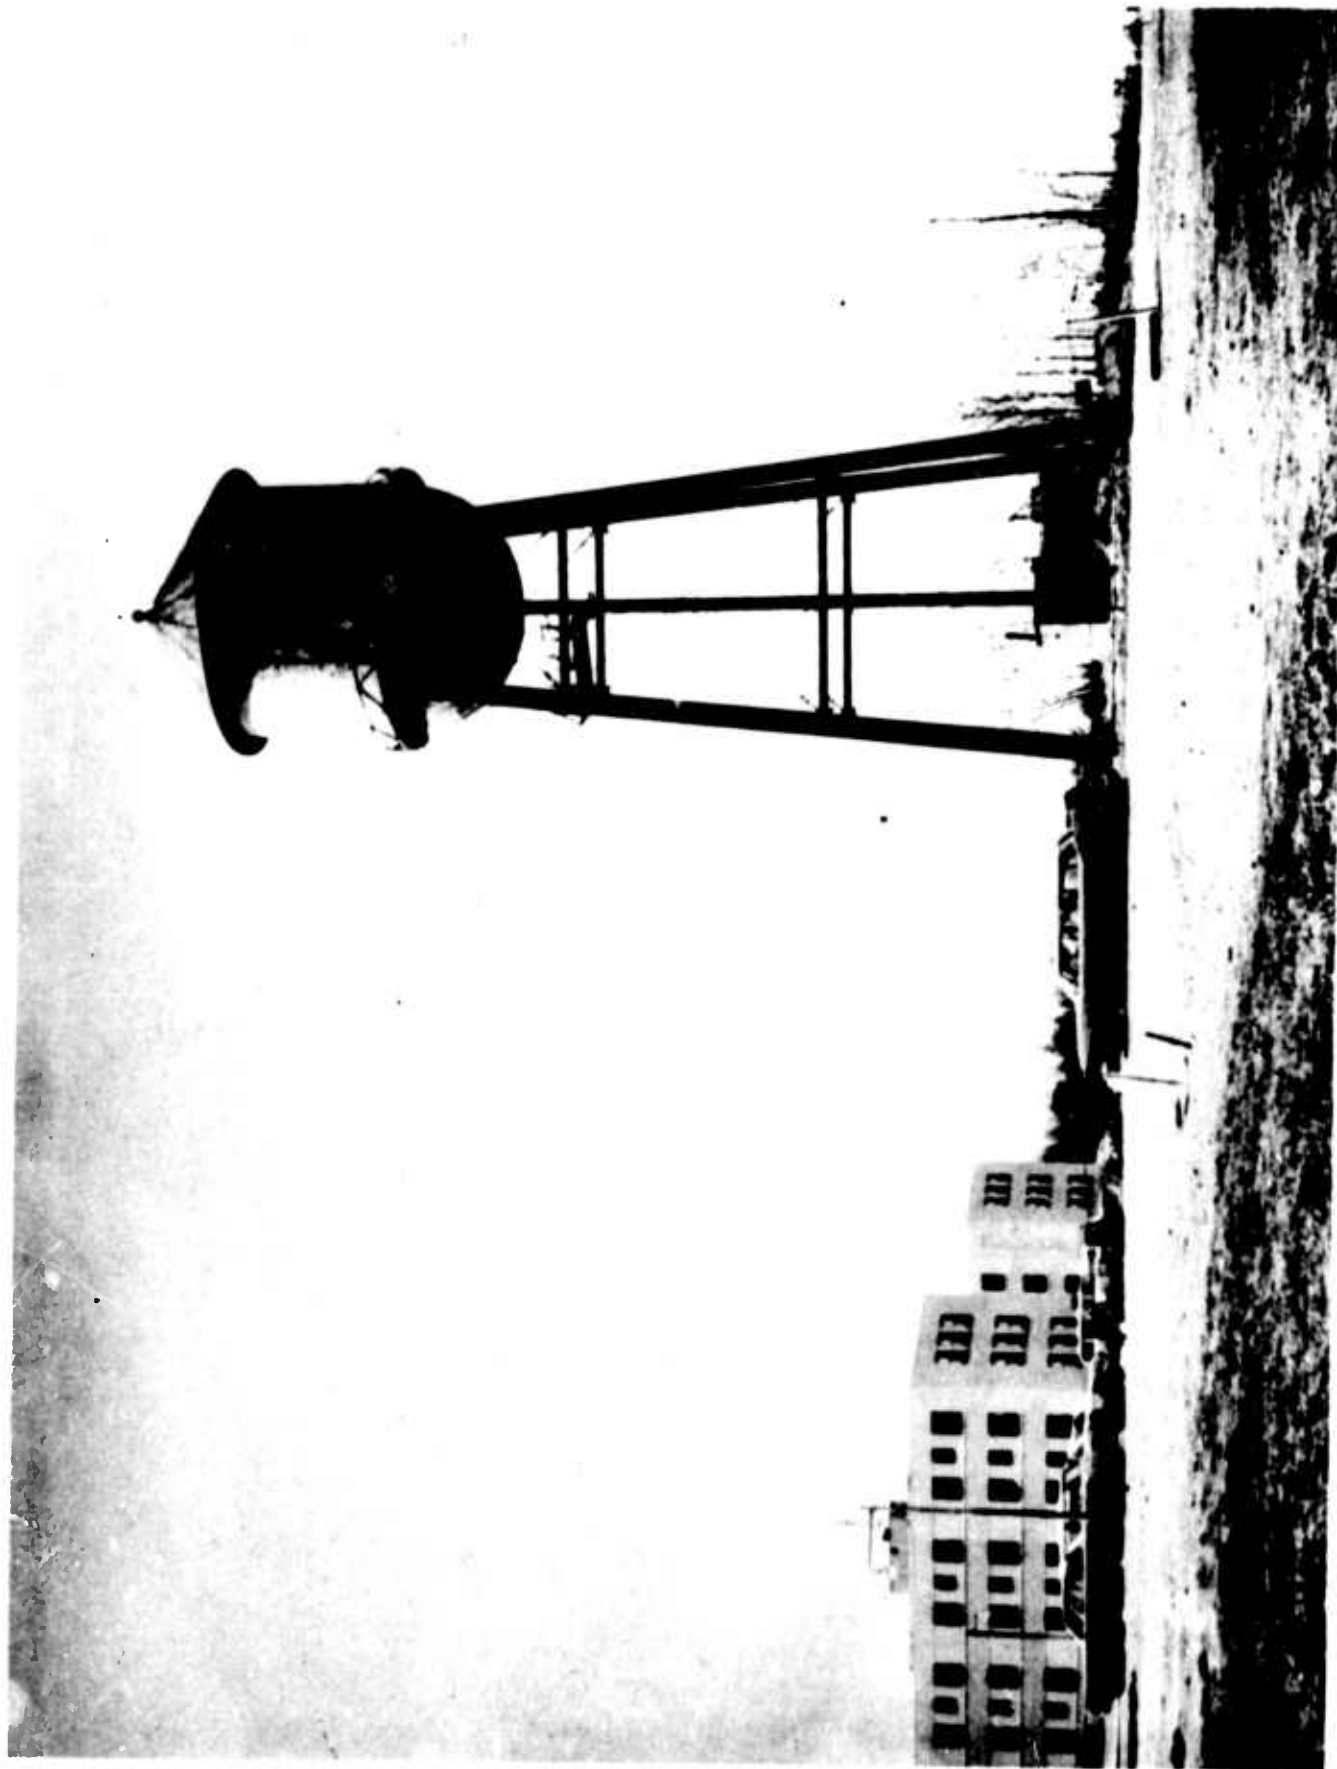
Figure 250. Alaska Native Hospital Water Tower (Forty-nine-year-old tower undamaged by the quake although it stands about one hundred feet from First Avenue slide. Tank was reported to have been empty when the quake struck.)

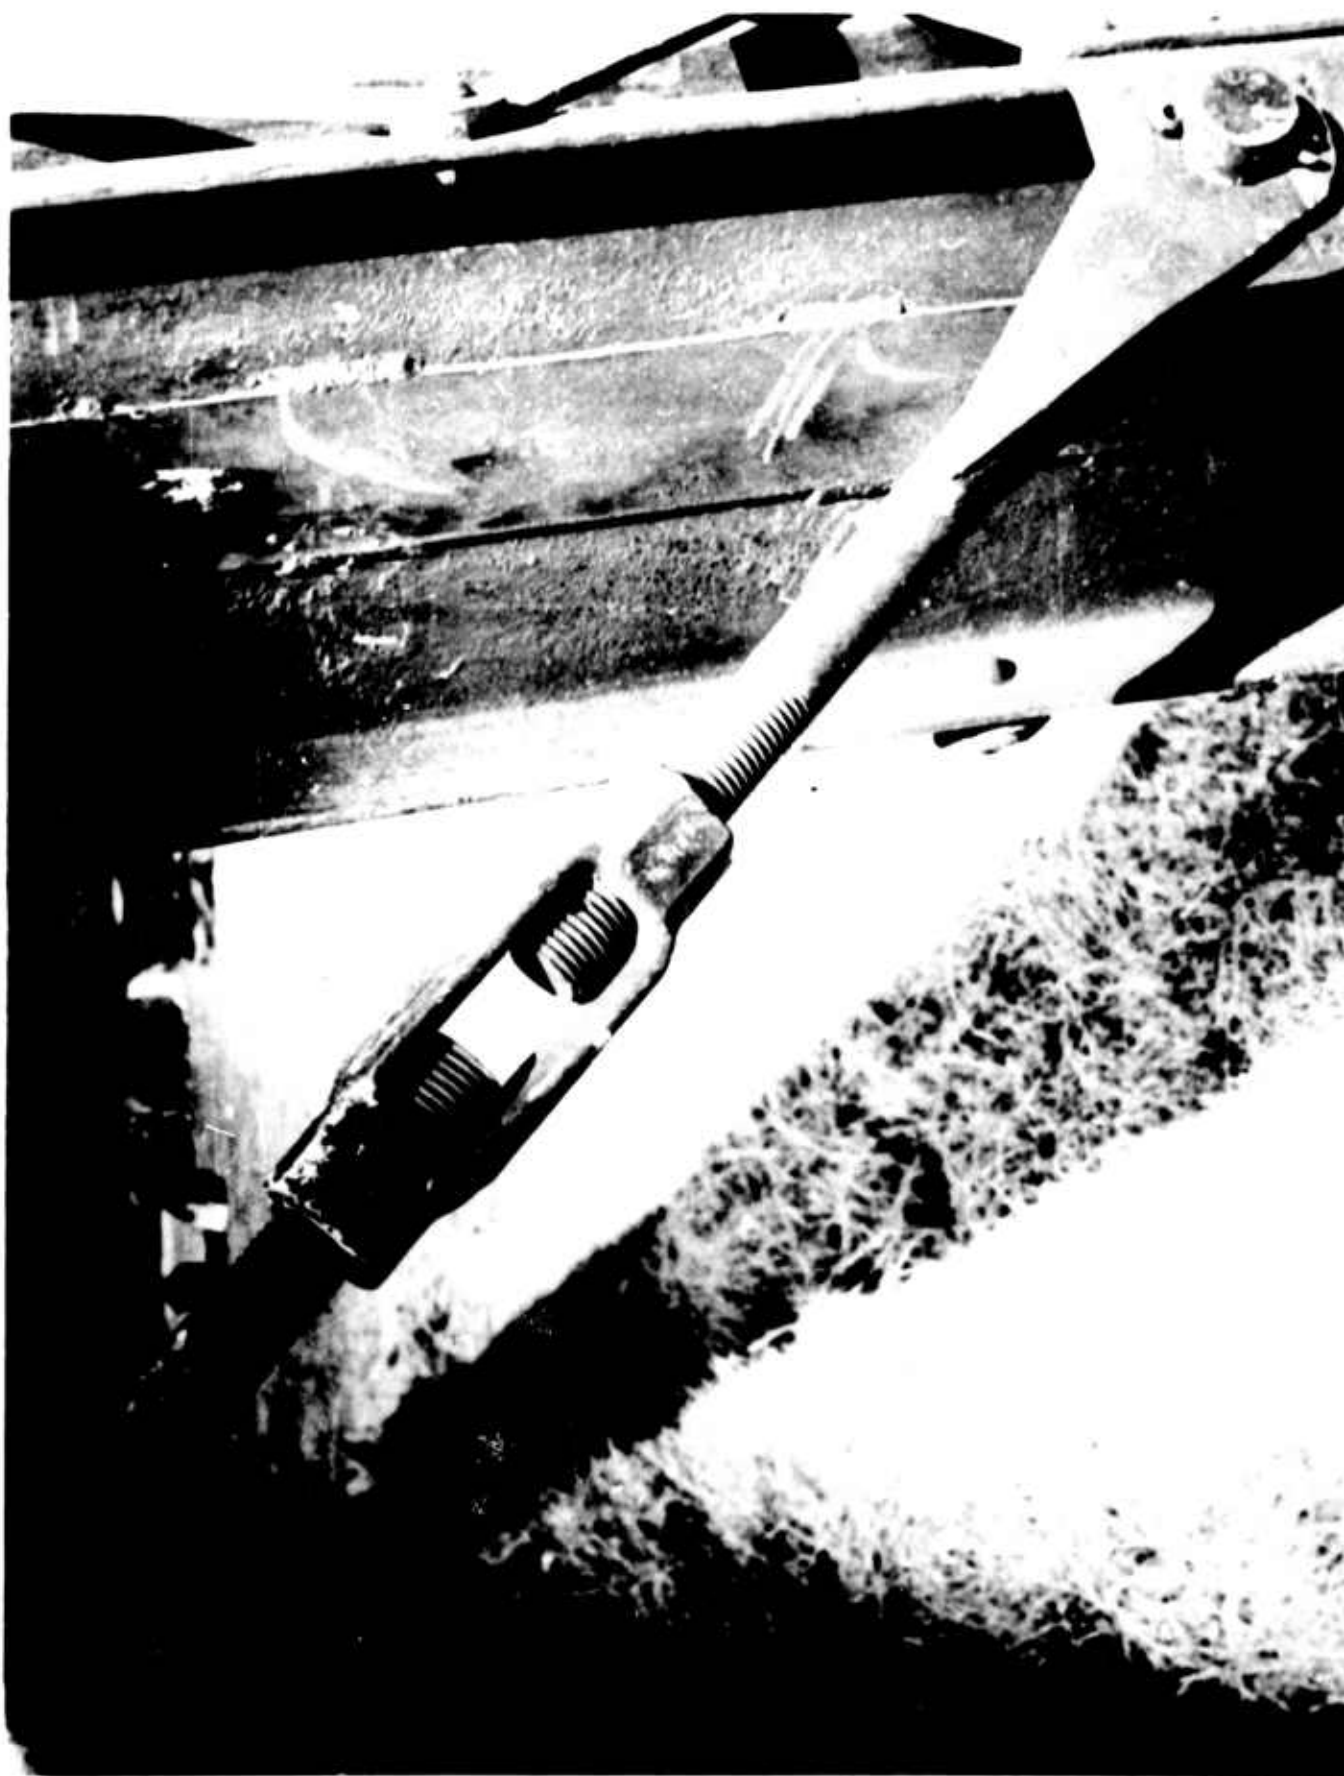
Figure 251. Alaska Native Hospital Water Tower
(Tie-rod turnbuckle at base of tower shows no sign of yielding)

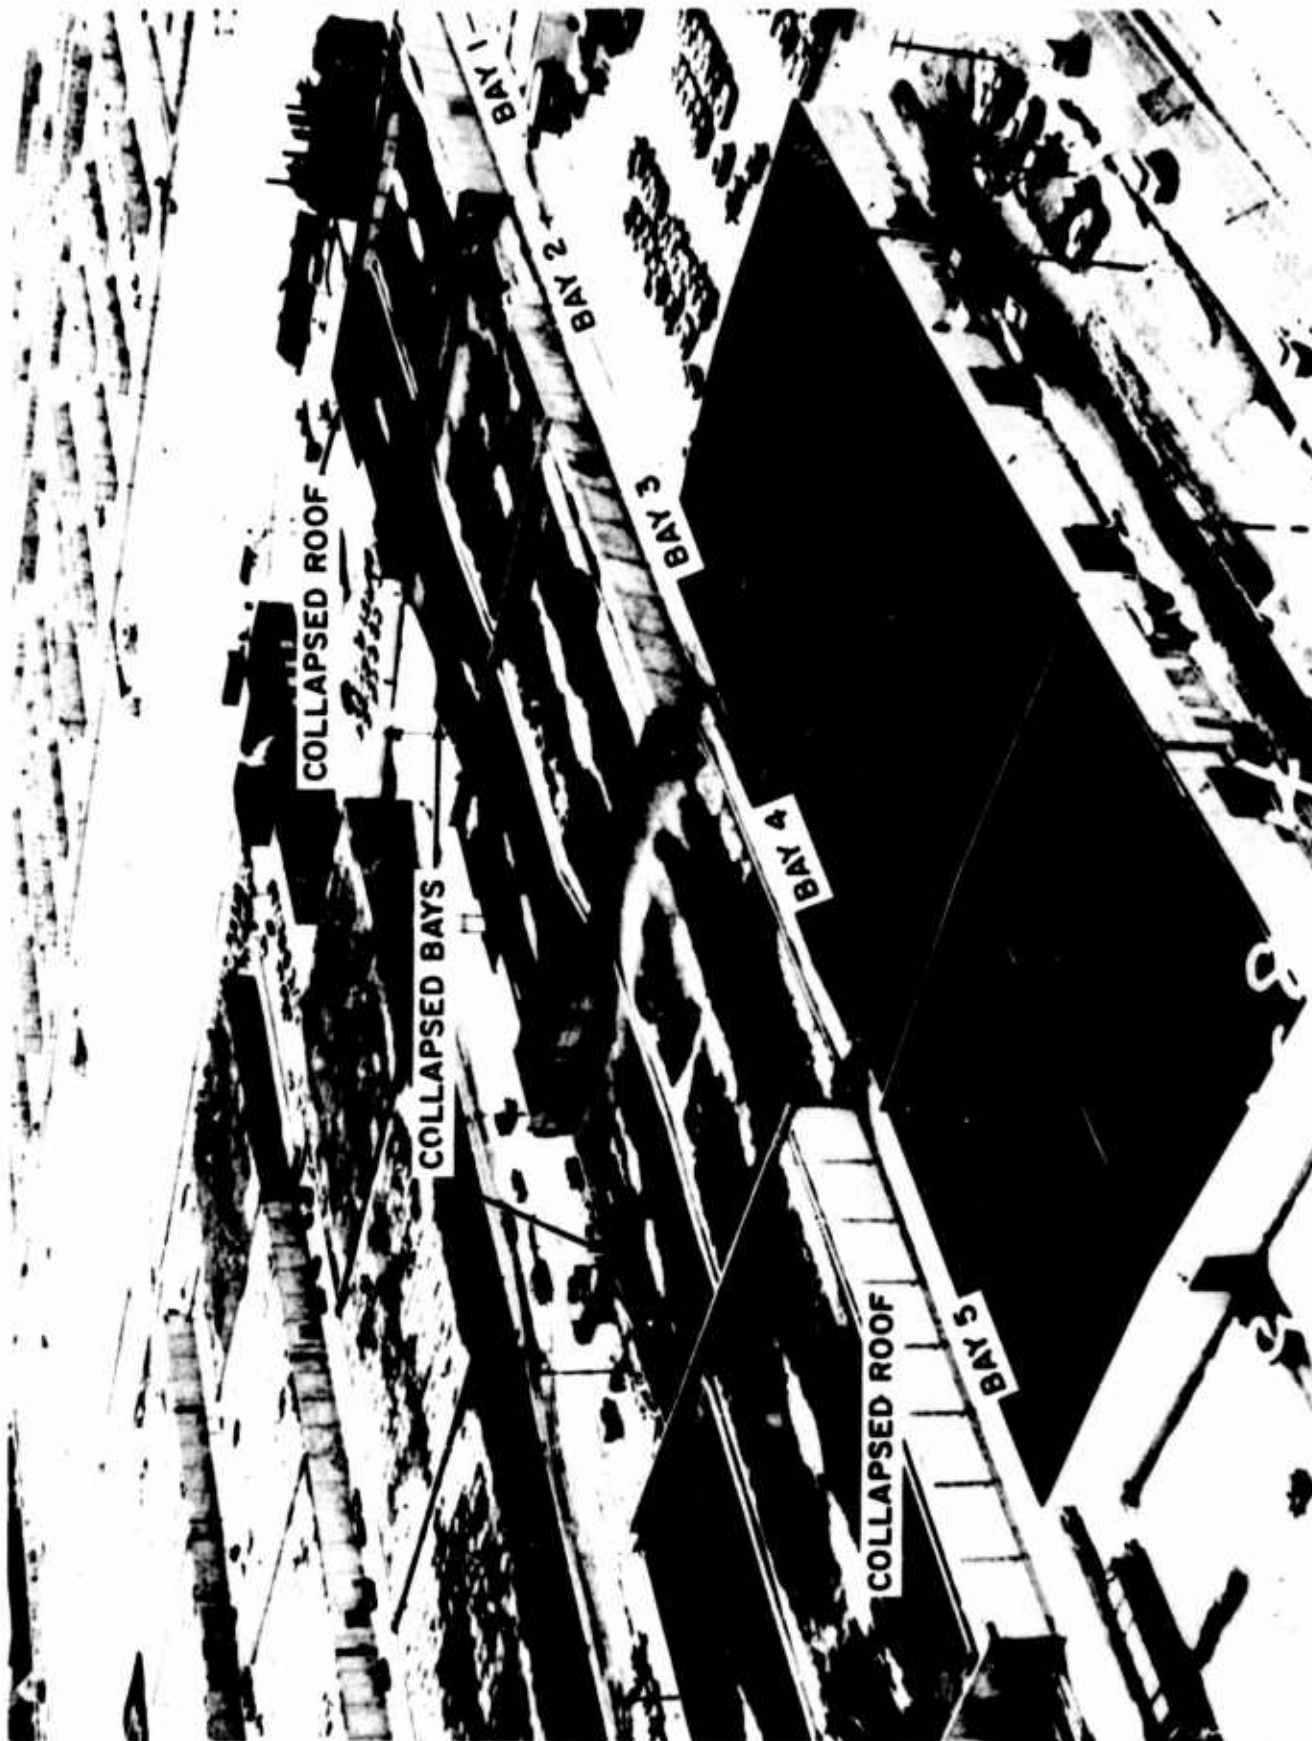
Figure 253. Elmendorf AFB Warehouse (Aerial view of partially collapsed supply warehouse)

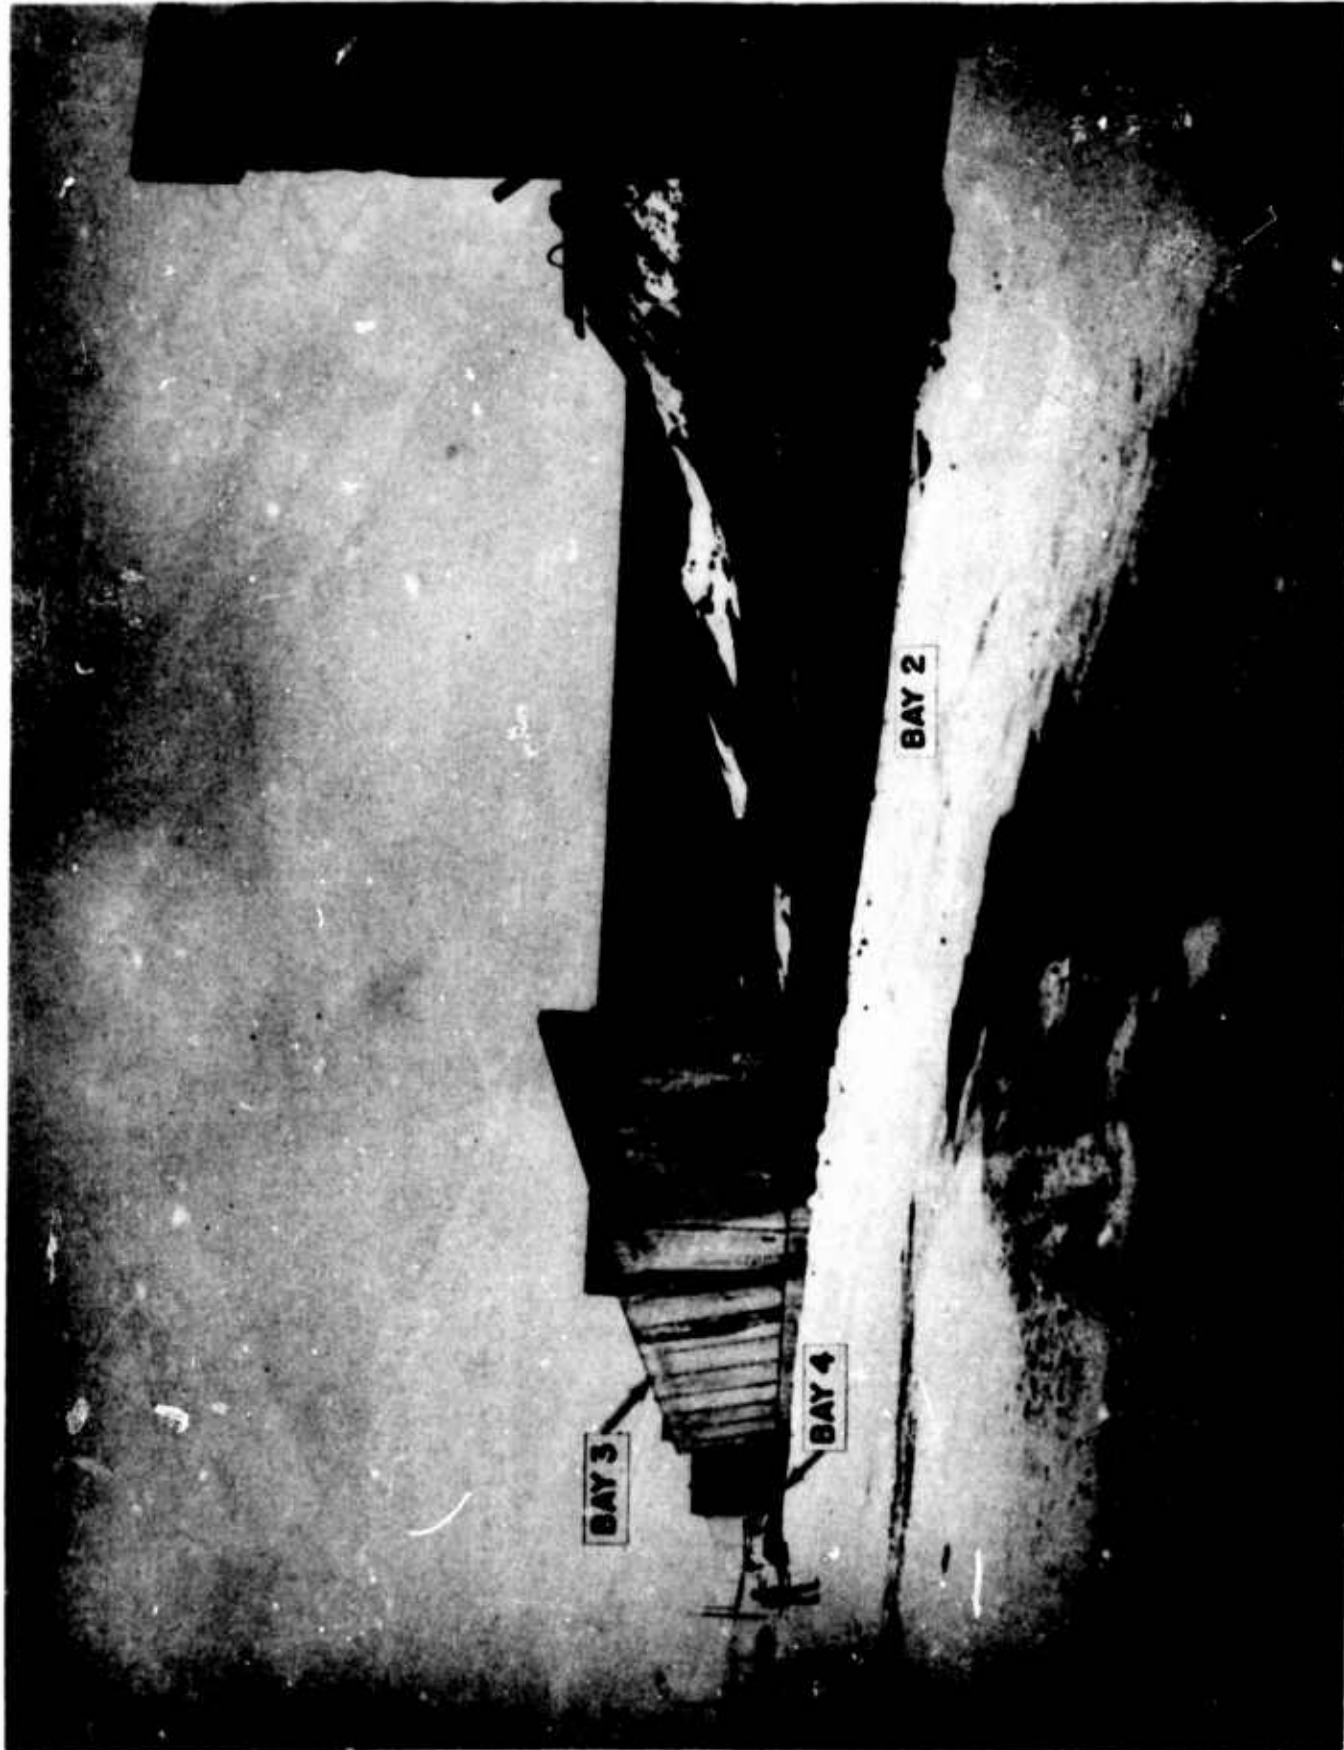
Figure 254. Elmendorf AFB Warehouse (Failed reinforced-concrete roofbeam seat--small horizontal ties were insufficient to resist lateral load)

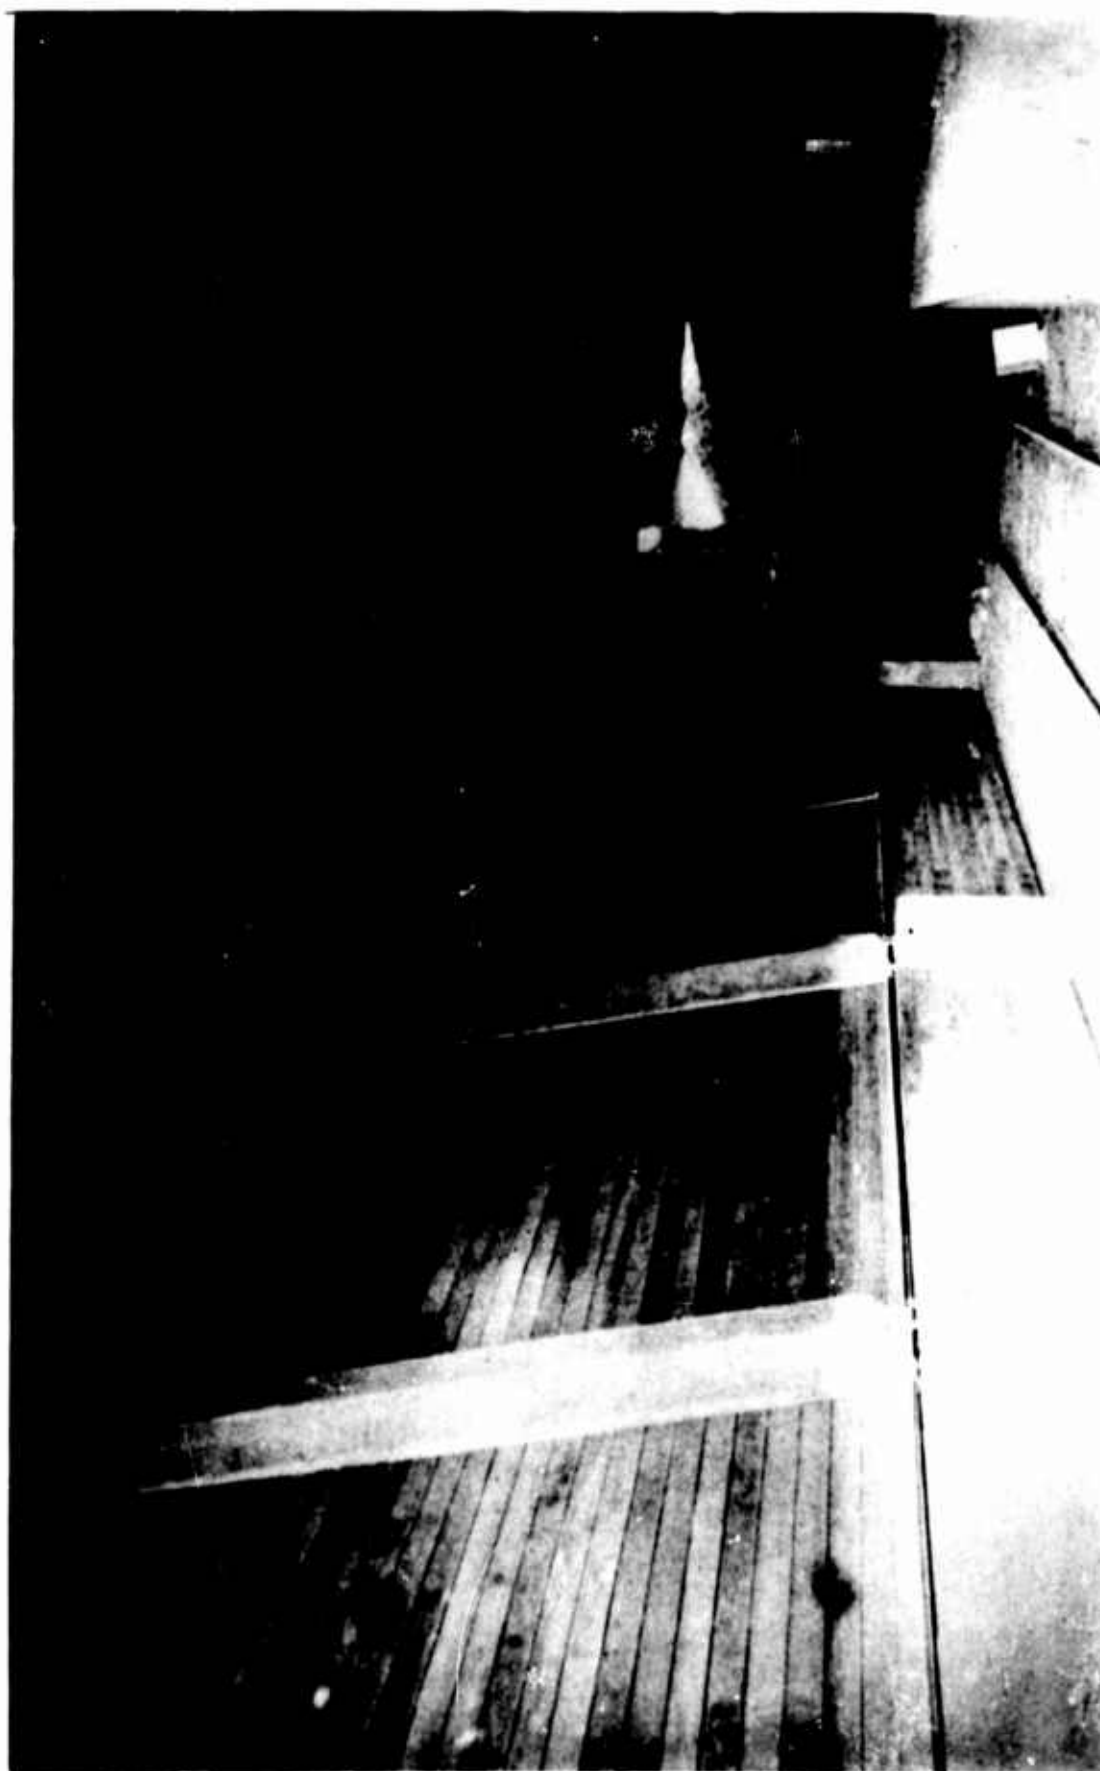
Figure 258. Elmendorf AFB Warehouse (Column failures along north wall of train shed)

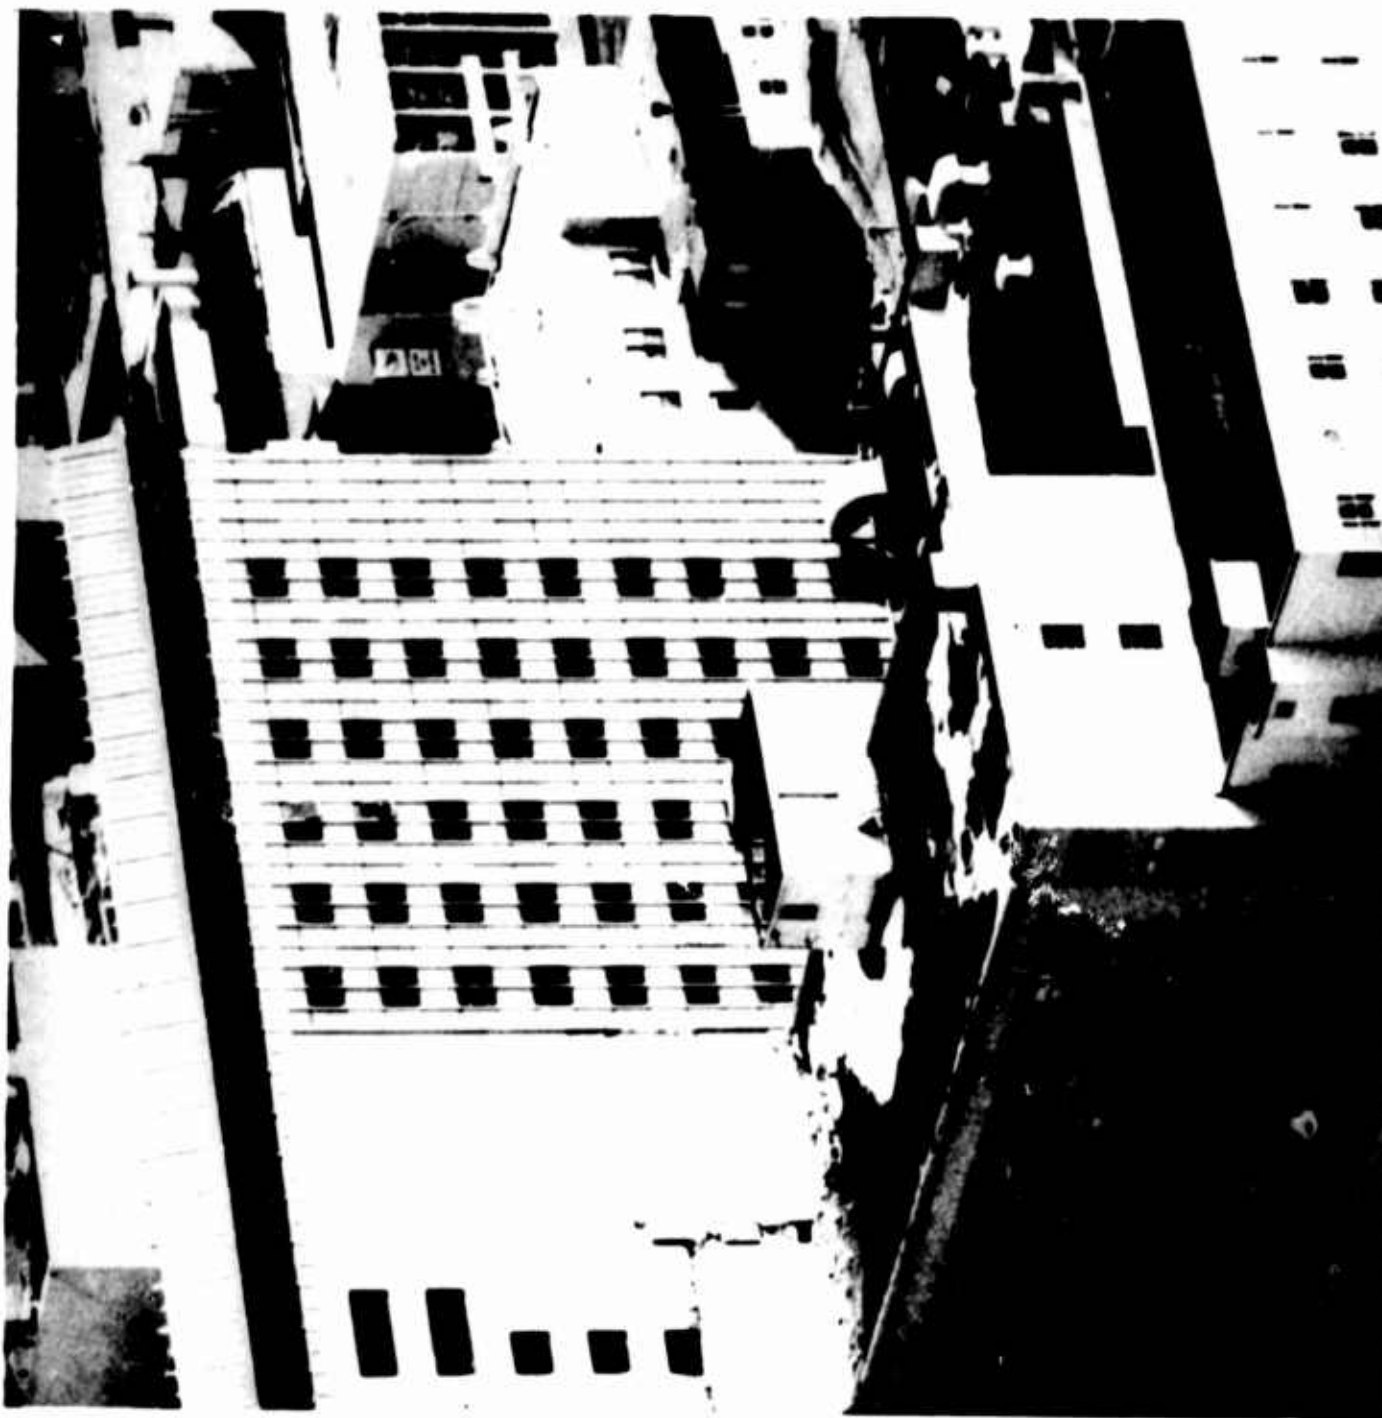
Figure 270. Anchorage Westward Hotel (Aerial view of west side of fourteen-story tower)
